NON-DESTRUCTIVE DAMAGE ASSESSMENT OF RCC BRIDGE DECK SLAB BY IMPULSE RESPONSE TECHNIQUE

ABSTRACT

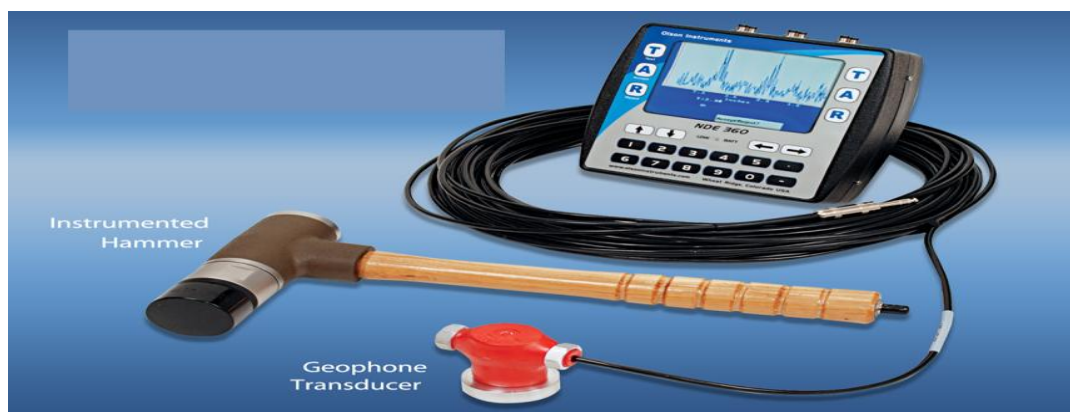
Fig 1.1: Slab Impulse Response Testing Apparatus

The Slab Impulse Response (SIR) system is designed to identify subgrade voids below slabs-on-grade less than two feet thick. The test is executed by impacting with an impulse hammer, which induced transient vibrations (up to 2 kHz). The impulse response function is a characteristic of a structure and it changes depending on geometry, support conditions and the existence of defects. Slab IR can be performed on reinforced and non-reinforced concrete slabs as well as asphalt or asphalt-overlay slabs. Figure 1.1 shows the picture of impulse response testing apparatus used.

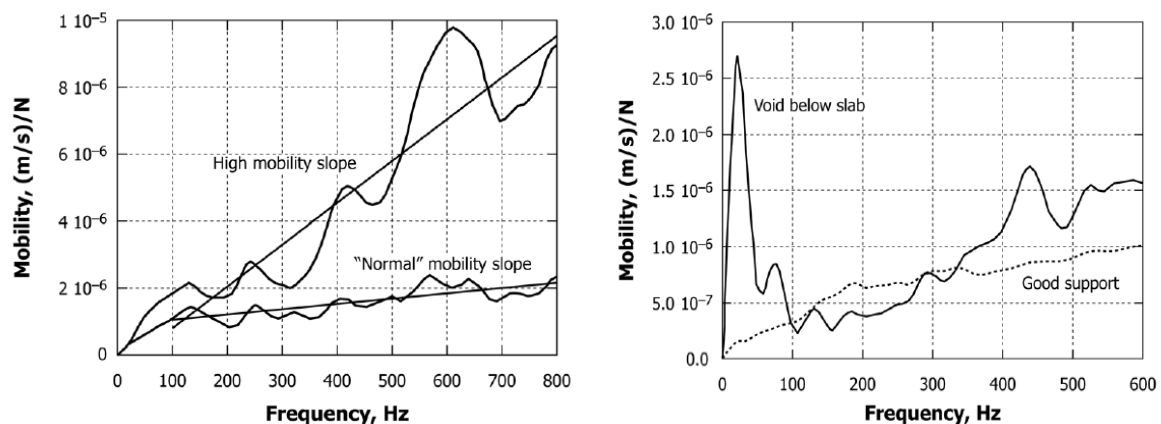
Fig 1.4.: Typical response due to flaws compared with sound responses.

If honeycomb in concrete is present, an increasing slope in the mobility plot is seen (left figure). If a void is present under a structure, a high mobility is measured at low frequencies (right figure).

4.	The voids index	The ratio of the maximum initial mobility to the average mobility. If delaminations are present or there is a lack of support of the structure, the peak mobility below 100 Hz is much higher than the average mobility (See the left side of Figure 3). If the value of the Voids Index is larger than 2-4 it's an indication of an area with a potentially poor condition (delamination or no support). ^[9]

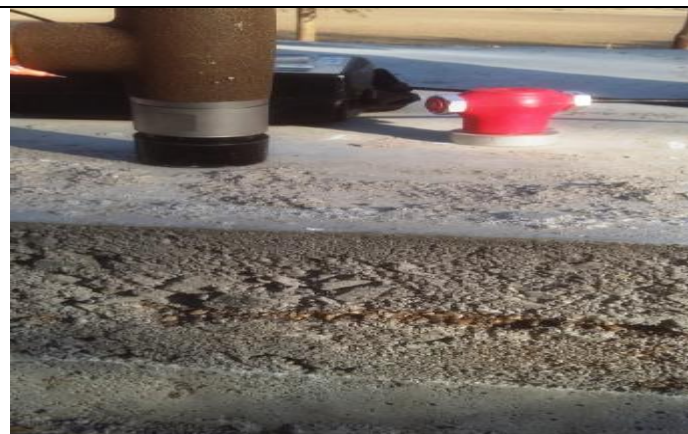
Figure 2.2. IR Testing in action on Honeycombed surface

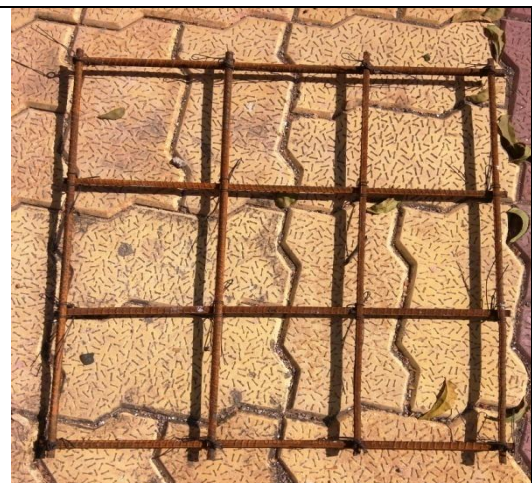
Figure 2.3: Corroded cage

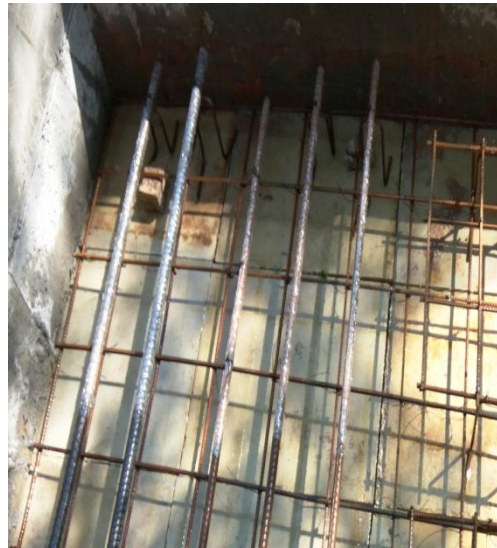
Figure 2.4: Reinforcement bars covered with plastic sheets fixed in position.

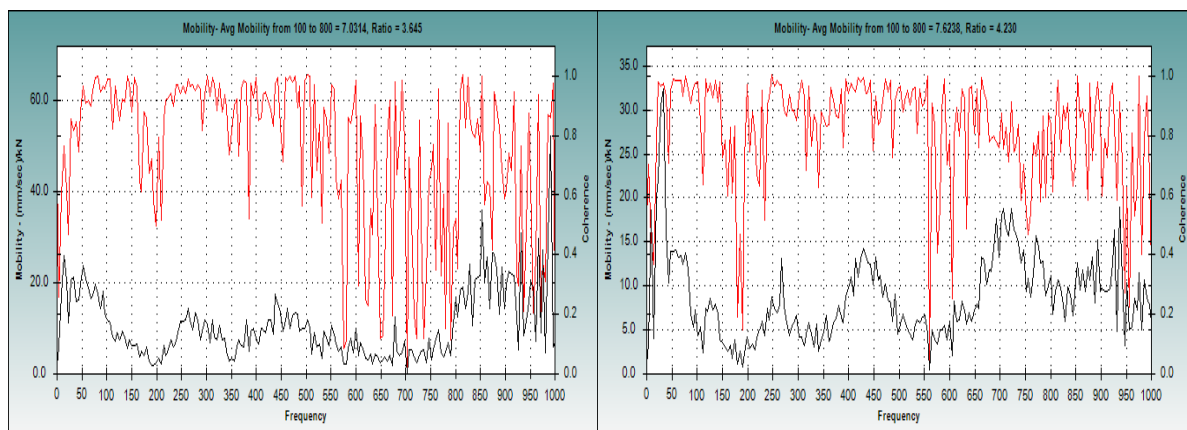
Figure 3.3: Mobility plots for sir 36 and sir 39 readings indicated corrosion.

Corrosion C1: Cage 1 C2: Cage 2 480x480 mm	C1	sir32.nde	0.2675844	7.1120551	4.0345862	Two Corroded reinforcement cages not show proper inference and need to be analysed further.
		sir33.nde	0.1005704	6.7460263	4.3027493	
		sir34.nde	0.1229476	7.7138238	4.1254178	
		sir35.nde	0.1057913	6.9780518	3.9919175	
	C2	sir36.nde	0.1138736	7.0314526	3.6455207	
		sir37.nde	0.2009689	8.4942865	6.1140532	
		sir38.nde	0.0984566	6.4594267	4.4448219	
		sir39.nde	0.10167	7.6238052	4.2302336	
Honeycombing		sir40.nde	0.2028536	117.4257239	0.5623612	A reduction of the thickness of the slab results in an increase in avg mobility referred to honeycombing.
		sir41.nde	0.0940118	150.9663379	0.5340089	
		sir42.nde	0.1740315	187.1648096	0.3074478	
		sir43.nde	0.1923518	160.4202781	0.4656907	
		sir44.nde	0.1528436	90.6432355	0.6209383

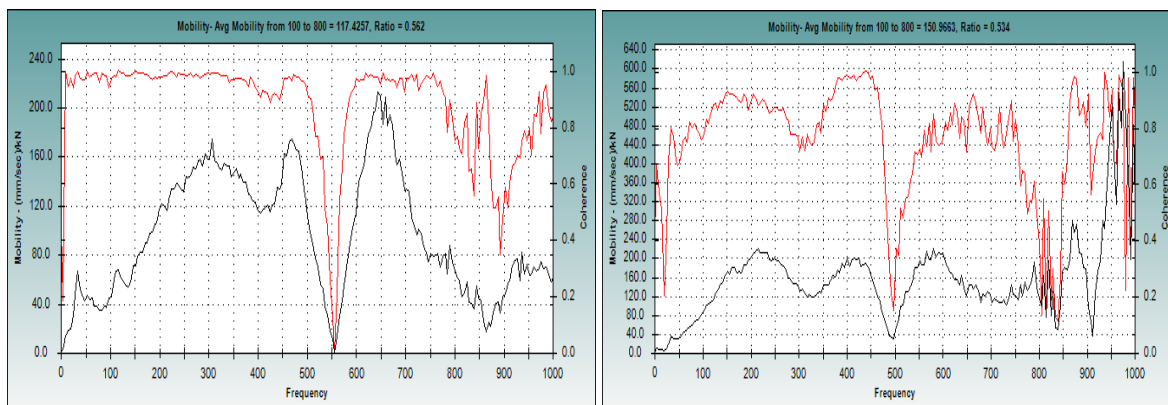
Figure 3.4: Mobility plots for sir 40 and sir 41 readings indicating Honeycombing.

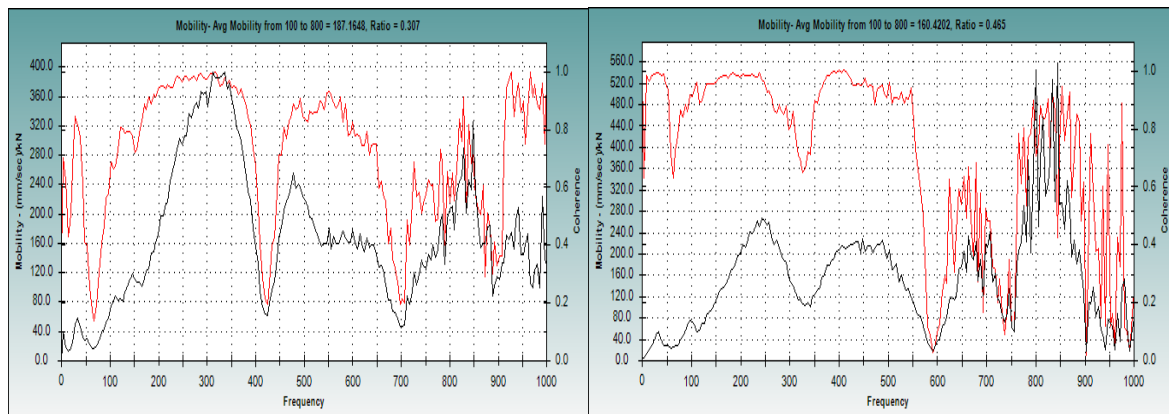
Figure 3.5: Mobility plots for sir 42 and sir 43 readings indicating Honeycombing
